## ARCHITECTURAL BARRIERS TO PEOPLE WITH DISABILITIES IN NIGERIA TERTIARY INSTITUTIONS: A CASE STUDY OF JOS

*P. S. \*Nimlyat; D, Gwatau*  
Department of Architecture  
University of Jos, Plateau State

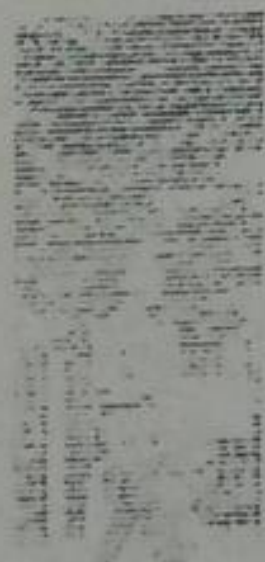
**Figure 1. Faculty of Social Sciences Building**

- The building housing the faculties of Arts and Social sciences is a multi storey building without any provision for an elevator (See figure 1). The absence of the elevator creates a barrier for wheelchair users and people with limited walking or manipulative abilities.

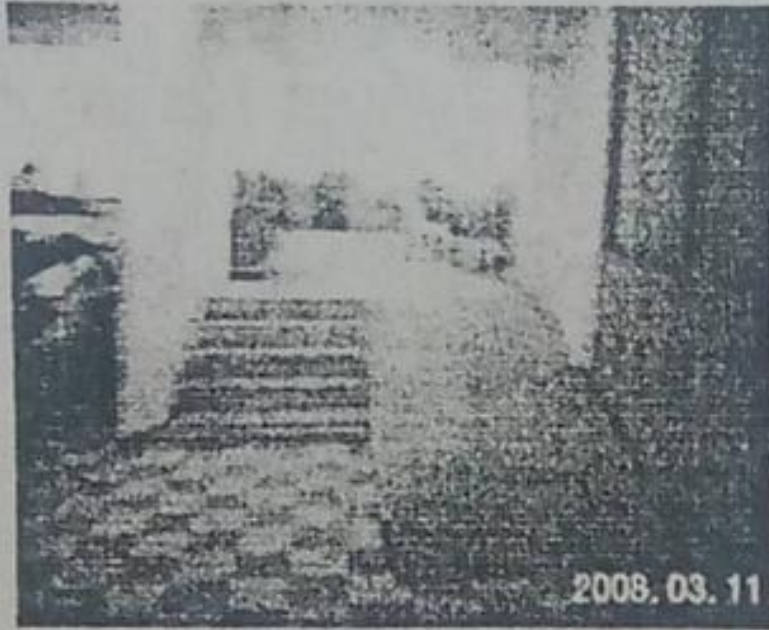
Figure 5. Ramp adjacent to Stair

- There are no complimentary ramped route at stepped accessible path and where change in level is unavoidable (Figure 4). Where ramp and a stair are provided, handrails are not installed for ease of movement (Figure 5). Where handrails are not installed on both sides of a stair, people with limited walking abilities and the sightless would find it difficult to use (Figure 4 and 5).
- Most ramps are not adjacent to stairs at change in levels (Figure 6).
- Most entrances to facilities are not accessible to ambulant disabled persons and the wheelchair users (Figure 7).
- Building entrances are not provided with minimum entrance landing (Figure 4).
- Corridors width does not allow for maximum manoeuvring in 180-degree turn especially in toilet areas (Figure 8).
- The overhang obstacles within corridors are mounted below the minimum height of about 2000mm.

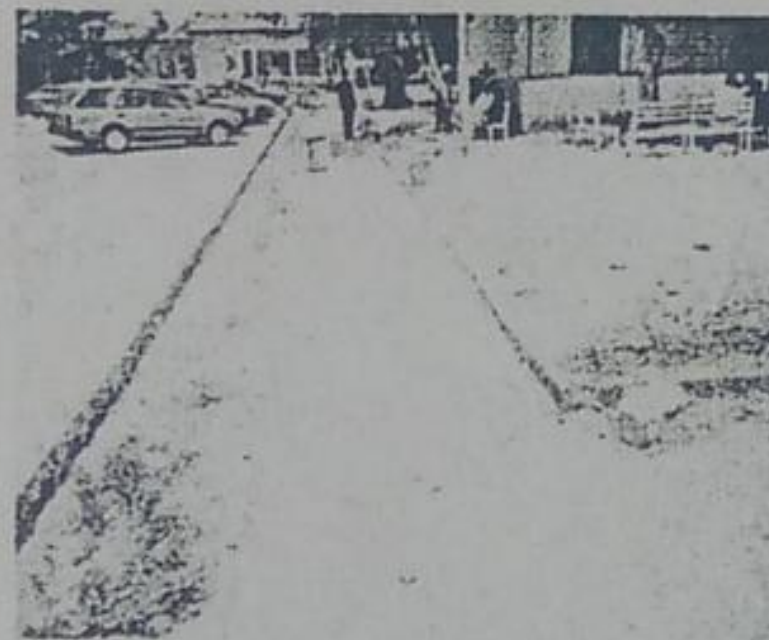
Figure 9. Pathway

- There is no parking space that is designated solely for the disabled.
- Accessible pathway surfaces are not smooth and even (Figure 9).
- Curb ramps are not provided at sidewalks or pathways crossing which also lack landing for wheelchair users.

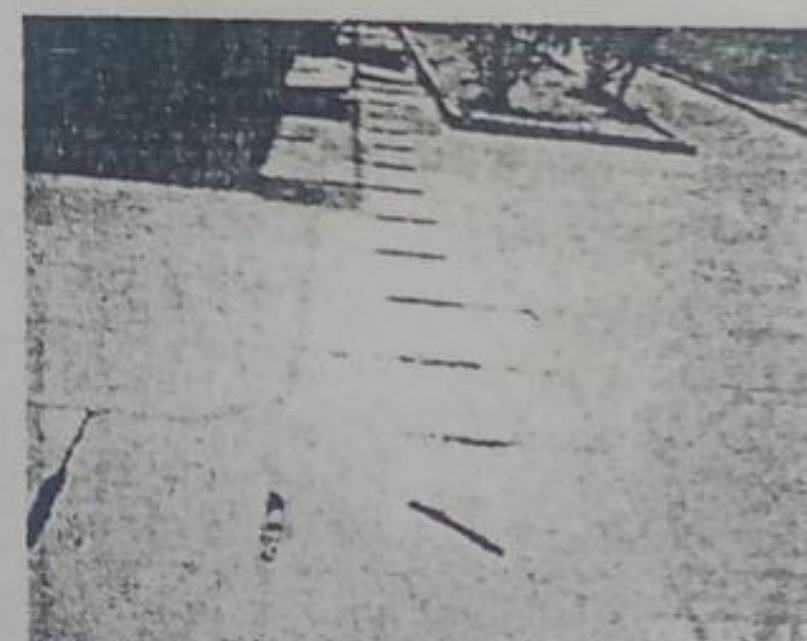
Figure 10. Gratings

- Drive way crossings are provided without curb ramps and landing.
- There are no tactile surfaces as detectable warnings for the visually impaired.
- Gratings are placed along pedestrian pathway which is hazardous to wheelchair, cane and crutch users (Figure 10).

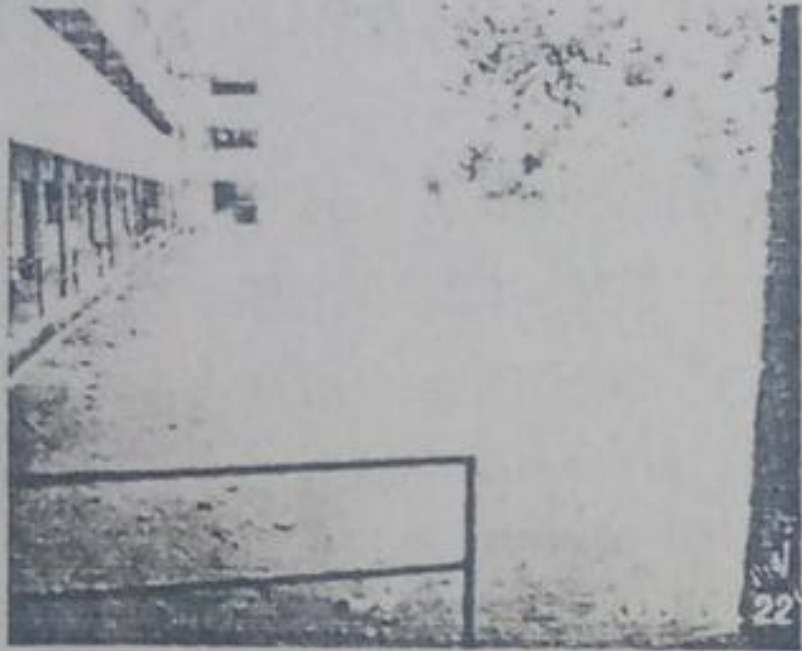
Figure 13. Main Lecture Halls

- The main lecture hall is a multi-storey building which lack accessible entries for wheelchair manoeuvring even at the ground floor (Figure 13).
- Other building facilities on only one floor have problem of circulation where steps are located without consideration for ramps (Figure 14).

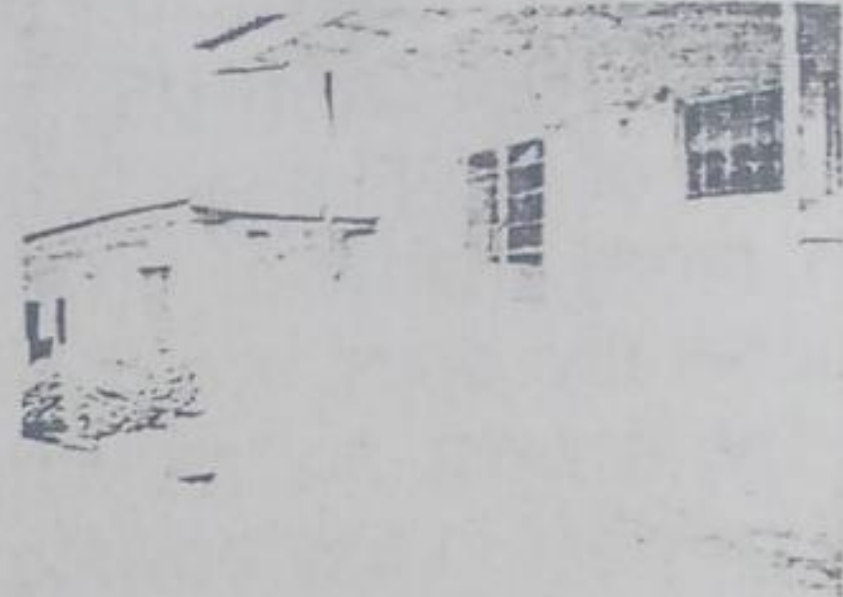
Figure 14. Lecture Hall

- The buildings design do not allow for easy access of people with disabilities as evidence in the lack of ramps and handrails at changes in levels (Figure 14).

- There is high amount of light within lecture room space which affects the visually impaired (Figure 18).
- Grab rails are not provided at elevated platforms more than 400mm (Figure 14).

- Steps for access to some of the building facilities are position in places where it will be difficult for the visually impaired to locate (figure 14).

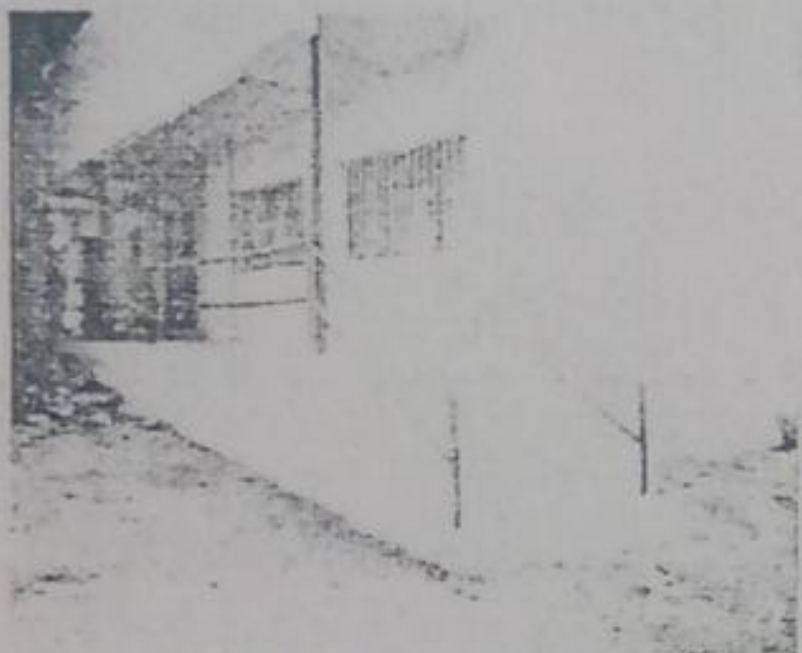
Figure 15. Stepped Pathway

- There are no complimentary ramped route at stepped accessible path and where change in level is unavoidable (Figure 15).
- Corridors width does not allow for maximum manoeuvring in 180-degree turn (Figure 26)

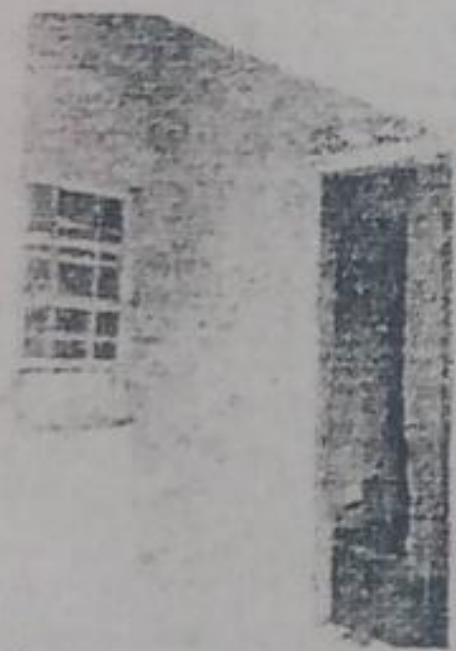
Figure 17. Toilet

- Spaces within toilets are inadequate to allow for wheelchair manoeuvring (Figure 17).
- The lecture rooms lack anti-glare filters and audio and visual feedback for individual with hearing or visual impairment.

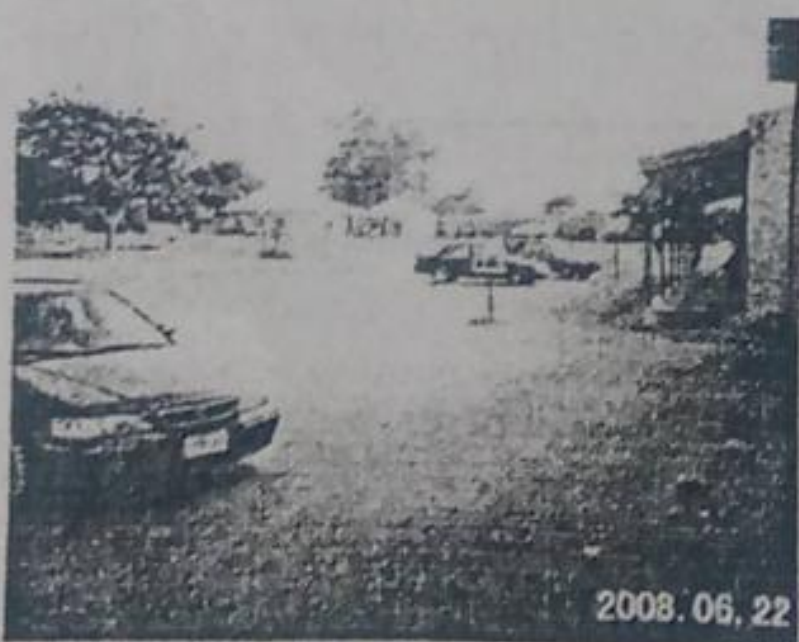
Figure 19. Parking Space

- The parking spaces are not defined which conflict with pedestrian routes. The spaces have not been properly organized to create a control environment for both the disabled and the abled persons (Figure 19). Lack of coordinated landscaping pose a serious trait to the accessibility issue of people with disabilities.
- Paved sidewalks or pathways are absent which create a problem of easy access of especially wheelchair users (Figure 13 and 19).
- Access features do not provide good orientation cues for pedestrians with visual impairment.
- Planting materials are located on the path of travel of pedestrian which are obstacles to the free movement of the visually impaired (Figure 20).
